## BUILDING & PEST INSPECTION REPORT

25 Keith St  
Kuraby, QLD 4112

03/09/2026

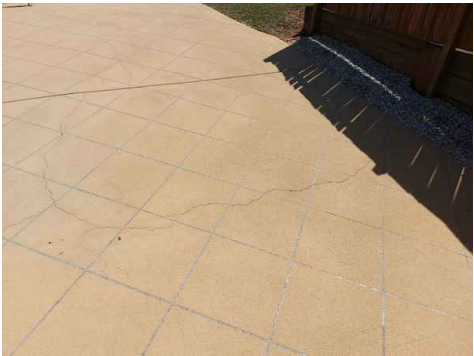
**COSMETIC CRACKS TO CONCRETE**

The minor cracks in the driveway/ paths are of a cosmetic nature.  
Recommendation  
Recommend monitoring.

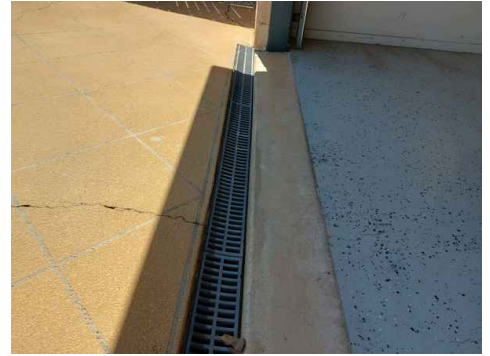
## 7.3.2 Driveway

**REVERSE SLOPE - DRAINED**

Areas were sloped towards the house. Drainage is in place, though we cannot determine adequacy. The area should be monitored and drains maintained to prevent water infiltration into the interior of the garage area. Recommend repairing or replacing the driveway to properly slope away from the garage.

Recommend monitoring.

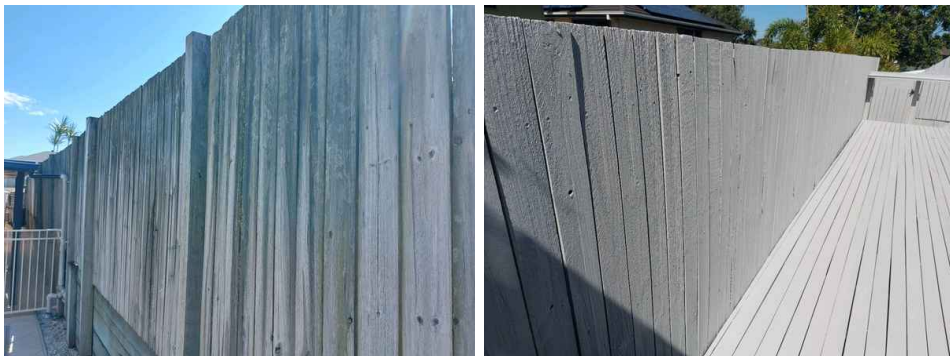
## 7.5.1 Fences/Gates

**TIMBER FENCES**

It should be stated that timber fences do have a finite service life. Timber and treatment to timber deteriorate over time, and require regular maintenance and replacement. Maintaining the bases of the fence posts and palings free and clear of soil, rotting leaves, and occasional treatment with a wood preservative will be most effective in prolonging service life.

Recommend monitoring.

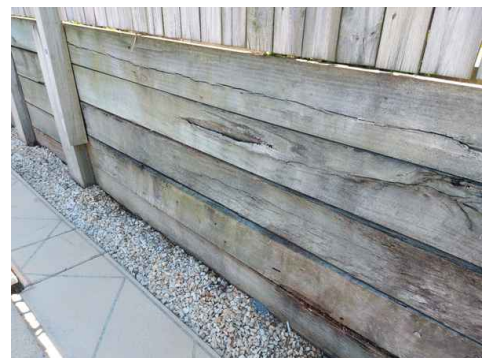
## 7.6.1 Retaining Walls

**TIMBER RETAINING WALLS**

It should be stated that timber retaining have a finite service life. Maintaining and occasional treatment with a wood preservative may prolong service life. Timber retaining walls will require maintenance and replacement once deteriorated.

Recommend monitoring.

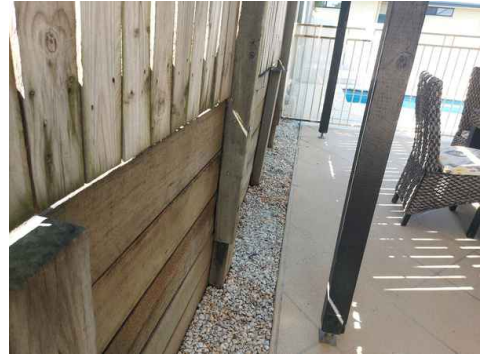
## 7.6.2 Retaining Walls

**LEANING**

The retaining walls appeared to be serviceable, but have moved from their original position, which means they have deteriorated. Further evaluation and correction recommended. Further deterioration is likely to occur over time.

It is best to perform repairs or replacement to retaining walls as maintenance prior to full failure.

Further evaluation and correction recommended.

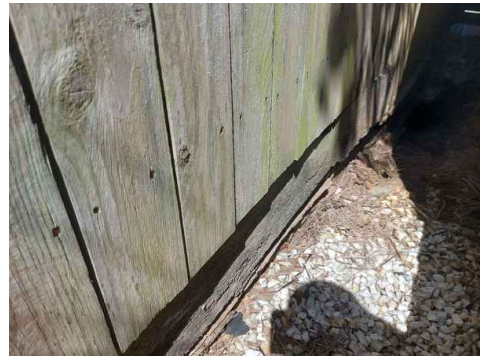
## 7.6.3 Retaining Walls

**MODERATE DECAY**

Moderate fungal decay damage was noted. Replacement of damaged timbers is required. Refer also to the Timber Pest Report.

Further evaluation and correction recommended.

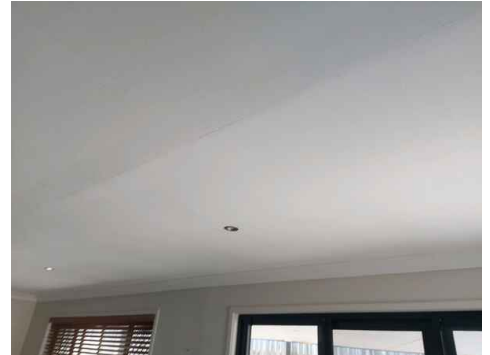
Poor finishes of joints observed. Further evaluation and correction recommended.

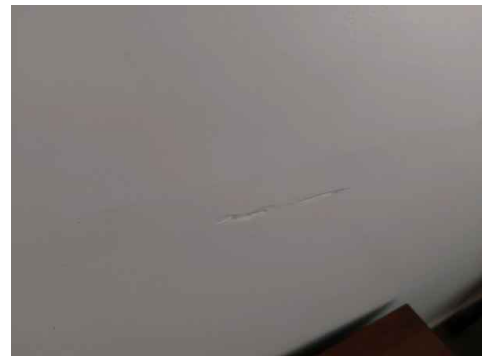
## 13.5.1 Walls

**MINOR DEFECTS - DENTS, MARKS, SCRATCHES AND THE LIKE**

Surface imperfections. Minor repairs and painting are required.

Recommend further evaluation at the time of works

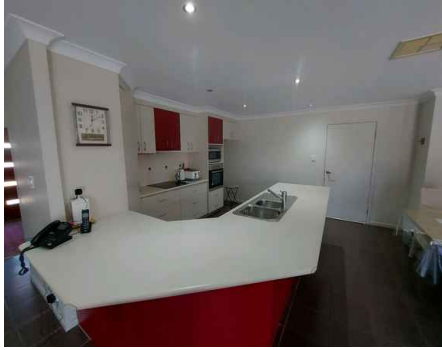
## 13.6.1 Doors

**LIGHT DAMAGE/DETERIORATION**

A door exhibited light damage or deterioration at the time of the inspection consistent with wear and tear. Maintenance recommended

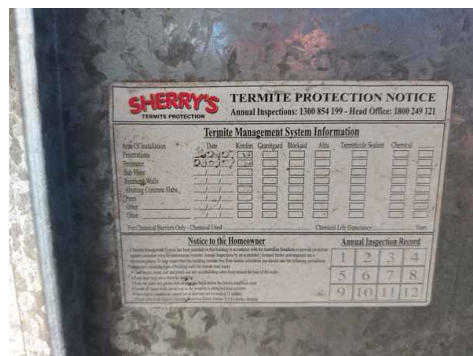
A notice indicates that the property may have had a termite management system during construction in respect to protection against subterranean termite attack. We strongly recommend any prospective purchaser attempt to verify this information and obtain copies of all relevant documentation.

Contact a qualified professional.
