# **PRE SALE PROPERTY INSPECTION**

1 Pomeroy Close, Underwood

# Visual Pre Purchase Building & Timber Pest Inspection Report

To comply with Australian Standard AS4349.1-2007 and AS4349.3-2010

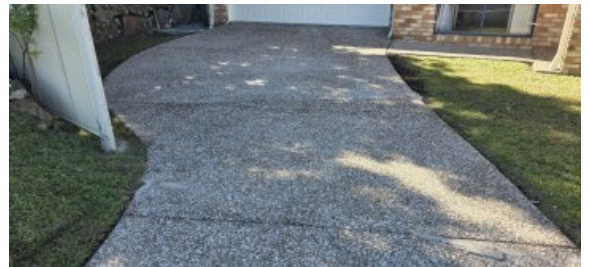
The concrete driveway stands in fair condition. The concrete driveway has some visible cracking that should be monitored for further movement.

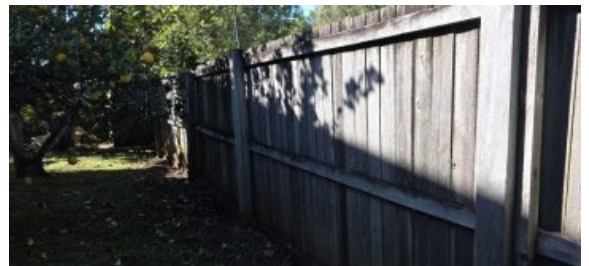
Wet rot decay and defects were noted to the wooden fencing. Repairs and or replacement of damaged timber will be required.

The fences are leaning and repairs will be required.

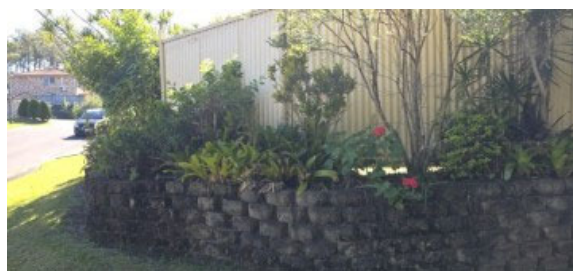
The retaining wall appears to be under designed. Recommend that you seek advice from Structural or Geotechnical Engineer.

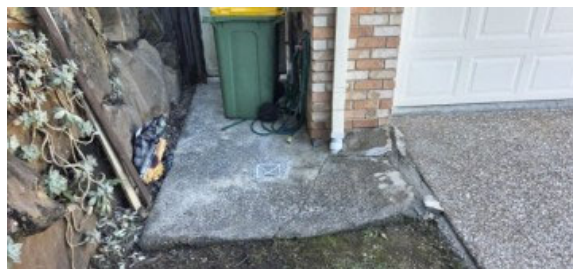
The paths/paved areas have some visible cracking and damaged areas may require repair and or replacement.

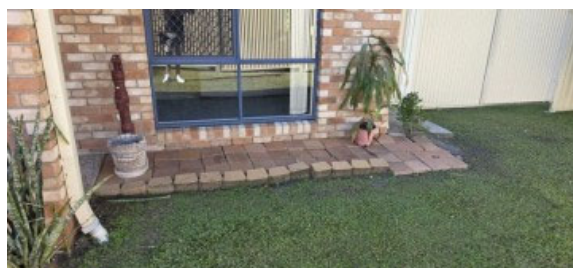
The paved paths/paved areas have subsided in areas and will require repair and or relaying.

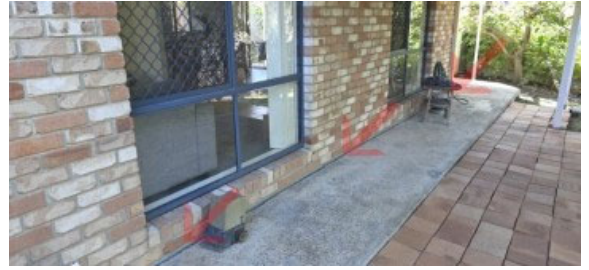
The paved paths/paved areas have subsided in areas and will require repair and or relaying.

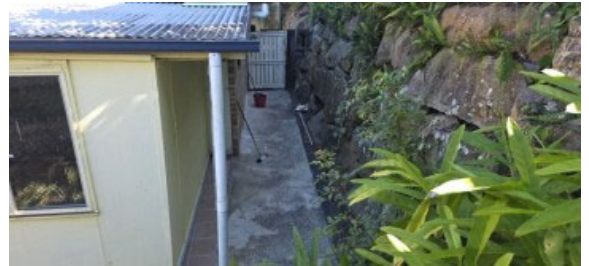
The paths/paved areas have some visible cracking and damaged areas may require repair and or replacement. Monitoring of this area is required and if further subsidence occurs engage a structural engineer.

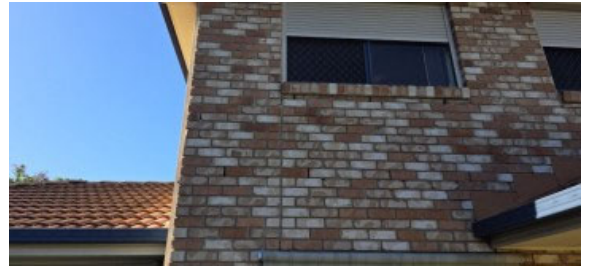
The condition of the walls is generally fair. Expansion joints to the brickwork are showing movement and require maintenance.

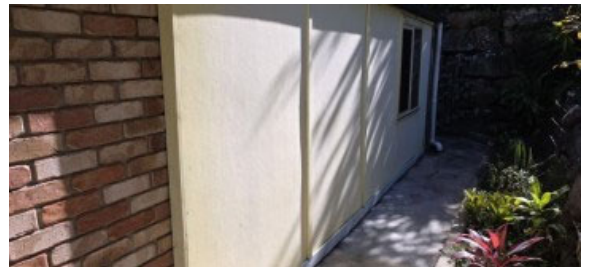
External cladding is in contact with or close to ground. This practice is conducive to timber pest attack and we recommend modifications be made to prevent contact with ground. Cladding is damaged and will require repairs and maintenance.

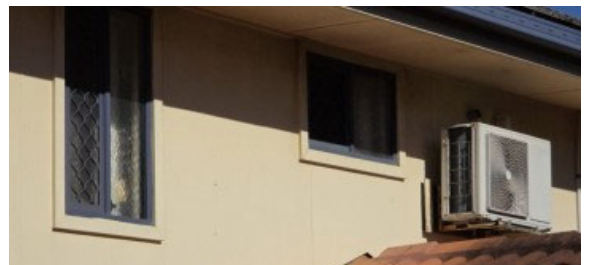
External wall sheeting is cracked. Repairs and maintenance will be required.

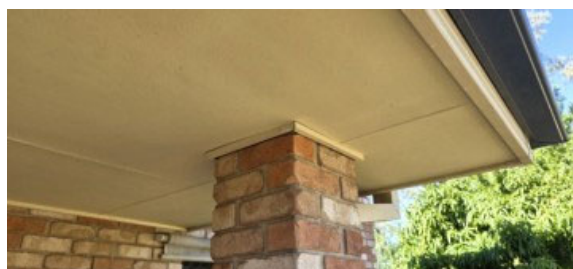
Trim timbers are loose and rectification is required  
Ceiling/soffit lining requires repair and or maintenance.

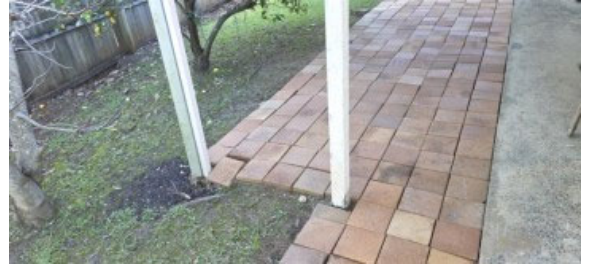
Some downpipes do not appear to be connected to a legal stormwater dispersal system. This should be rectified.

Erosion noted in areas and rectification is required.

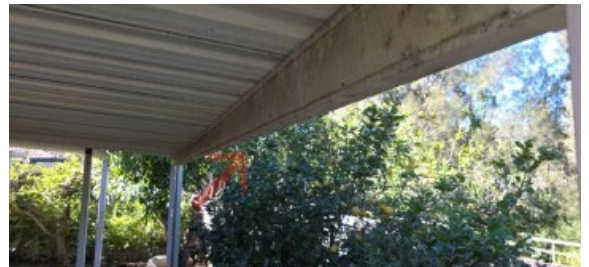
Rusting and bowing noted to metal support and repair as required.

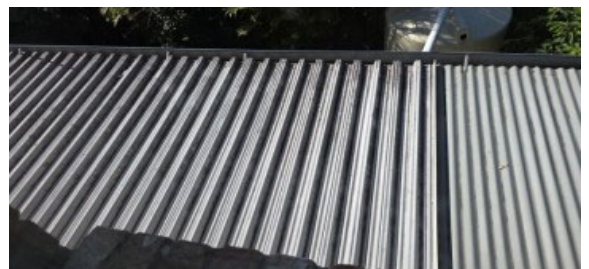
Roof area should be cleaned to remove, lichen and or moss buildup. Some repair & maintenance of the roofing material may be required following clean. A roofing expert should further evaluate the roof area.

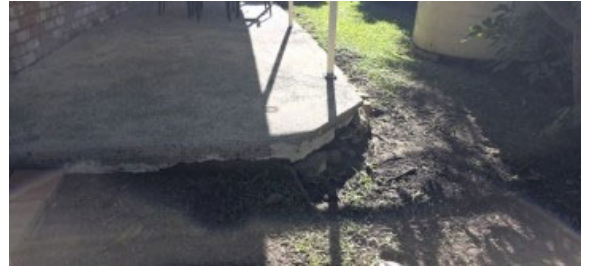
Erosion noted and rectification will be required.

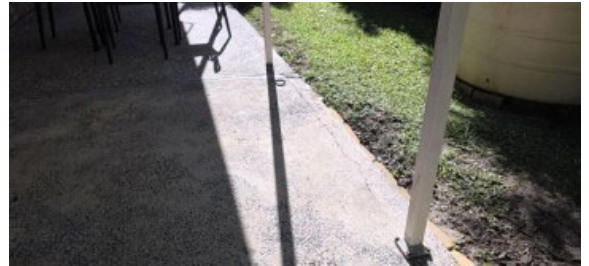
Cracking and settlement is noted to the floor area. Damaged areas require repair or replacement. Please refer to section of this report - CRACKING OF BUILDING ELEMENTS for additional details.

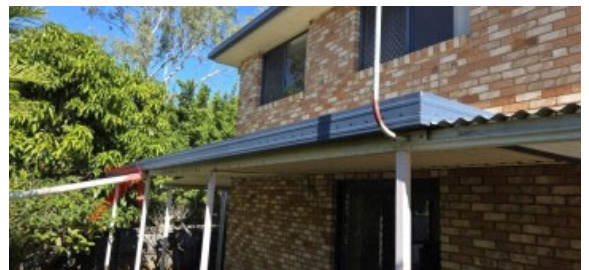
Gutters are damaged and should be repaired as necessary.

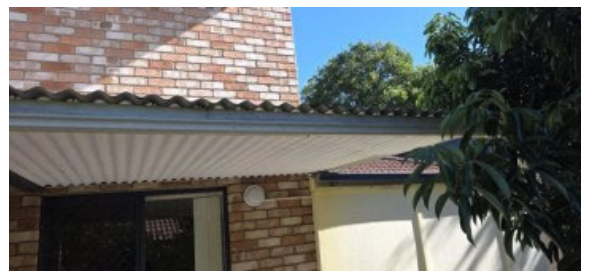
Gutters and or downpipes are not present to part of this roof area to . Recommend guttering be installed to comply with current Standards.

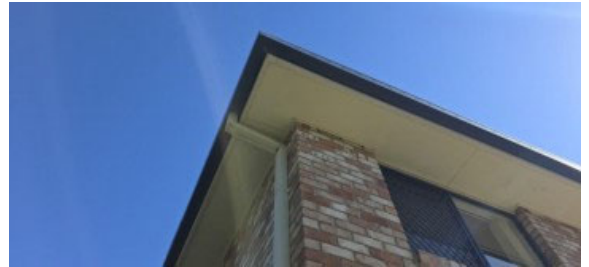
Guttering/Downpipe joints are leaking and repairs/maintenance required.

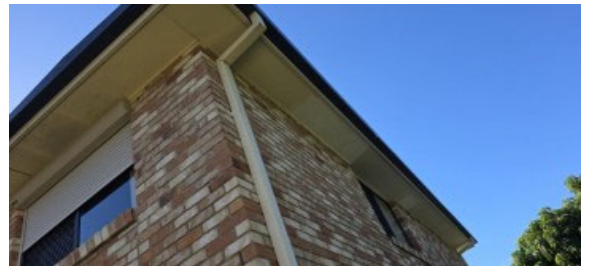
Mould was noted to the eaves lining. The cause of this mould should be further investigated by an expert in mould detection and analysis. Recommend a specialist be commissioned to report on all mould present to this property.

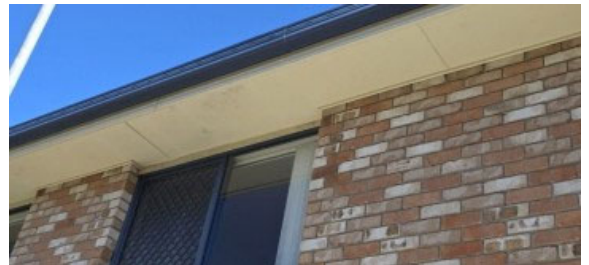
Mould was noted to the eaves lining. The cause of this mould should be further investigated by an expert in mould detection and analysis. Recommend a specialist be commissioned to report on all mould present to this property.

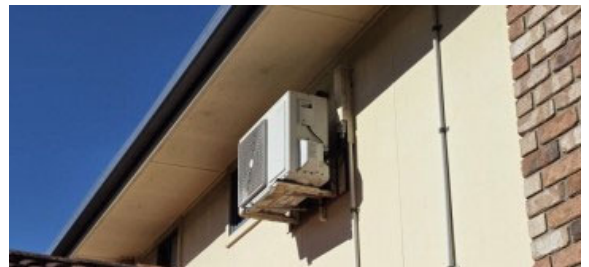
Mould was noted to the eaves lining. The cause of this mould should be further investigated by an expert in mould detection and analysis. Recommend a specialist be commissioned to report on all mould present to this property.

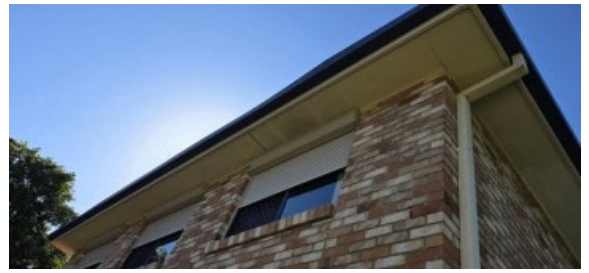
Mould was noted to the eaves lining. The cause of this mould should be further investigated by an expert in mould detection and analysis. Recommend a specialist be commissioned to report on all mould present to this property.

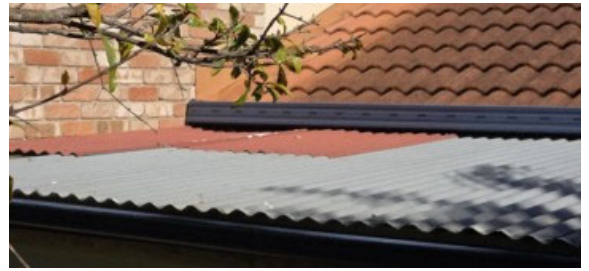
The overall condition of the roof coverings is fair. Metal roof sheets have been end lapped which is not considered good practice and can allow water to penetrate and cause corrosion. This should be rectified.

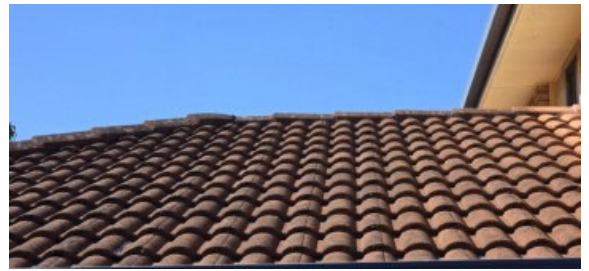
The overall condition of the roof coverings is fair. Roof area should be cleaned to remove, lichen and or moss buildup. Some repair & maintenance of the roofing material may be required following clean. A roofing expert should further evaluate the roof area.

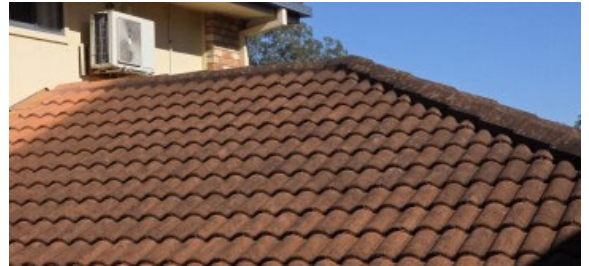
Roof area should be cleaned to remove, lichen and or moss buildup. Some repair & maintenance of the roofing material may be required following clean. A roofing expert should further evaluate the roof area.

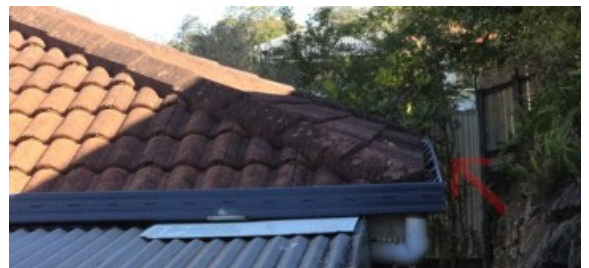
Some downpipes are missing. Recommend downpipes be installed and connected to a legal point of discharge.

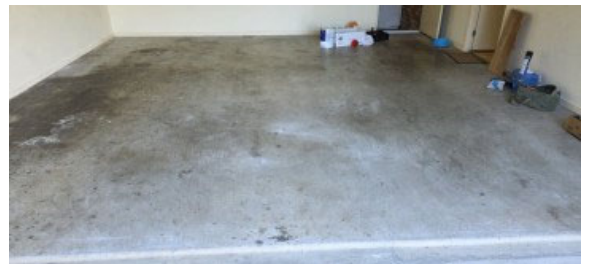
The concrete floor is generally in fair condition. The concrete floor shows signs of minor cracking. Please refer to section of this report - CRACKING OF BUILDING ELEMENTS for additional details. Concrete floor is stained and marks may not be able to be removed.

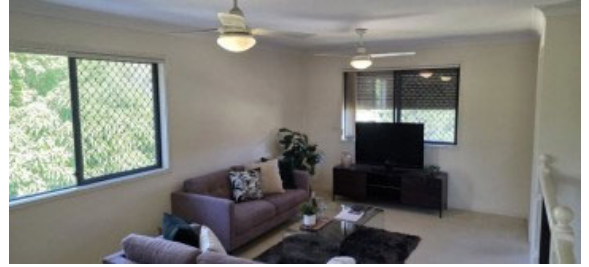
Minor maintenance and or repairs are required prior to next repainting. Squeaking or loose flooring was noted. Consider securing these areas to prevent movement.

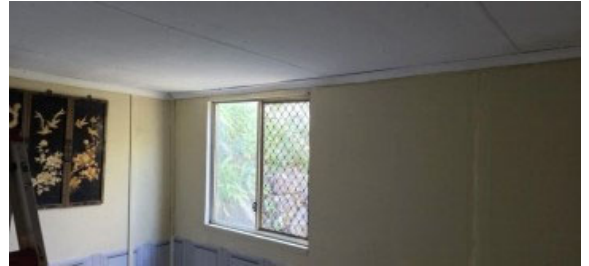
Ceiling height to the area is below Standards of 2400mm and not suitable as a habitable area. Damage noted and repairs required in areas.

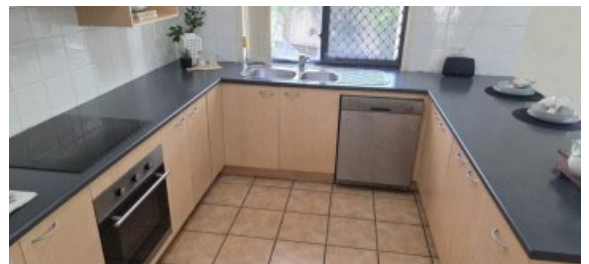
The condition of the fixtures is generally fair. Wear and tear is noted to cabinets and some maintenance or repairs will be required. Maintenance and adjustments should be considered to doors/drawers to provide smooth operation.

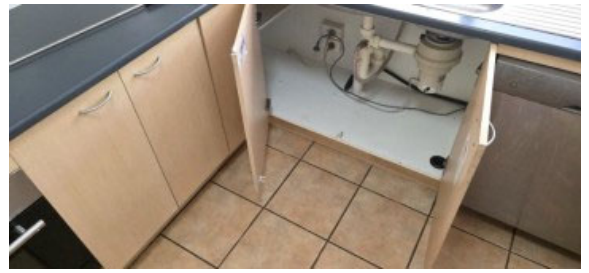
The laminate is lifting in some areas.

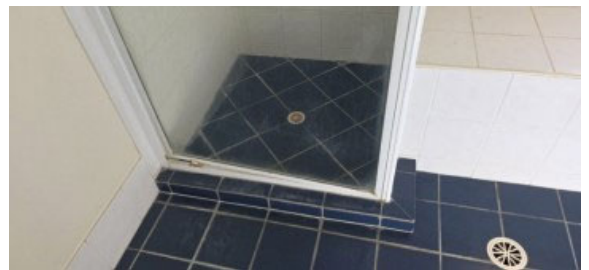
Junction of shower screen and shower base should be resealed appropriately to prevent water entry to wall cavity.

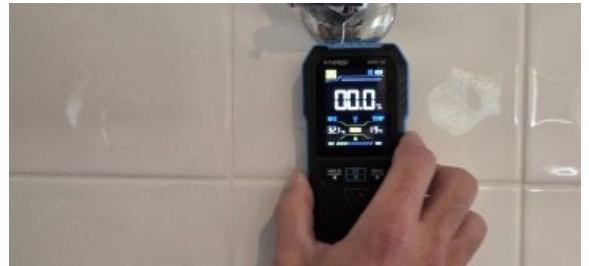
Junction of wall finish and shower base should be resealed appropriately to prevent water entry to wall cavity.

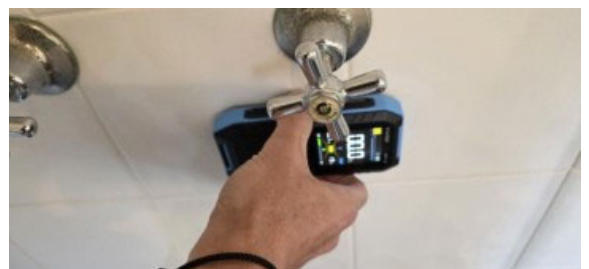
Recommend all aging, worn and or missing tap hardware be professionally serviced and or upgraded.

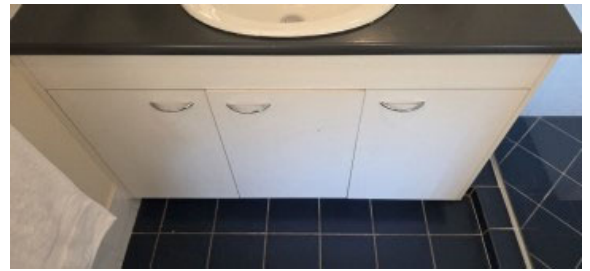
The condition of the vanity unit is generally fair.  
The vanity unit is damaged and will require repair.

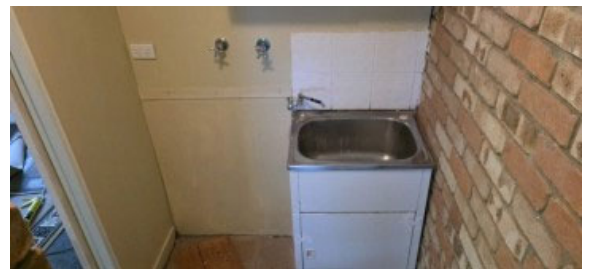
Behind garage.  
Minor damage noted requiring repairs.

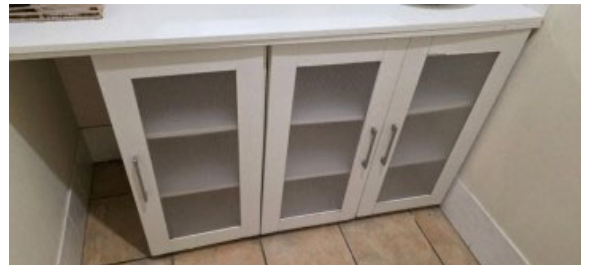
The vanity unit is damaged and will require repair.
