## BUILDING & PEST INSPECTION REPORT

27 Greenhaven Cres  
Kuraby, QLD 4112

Mark Gillman  
30/07/2026

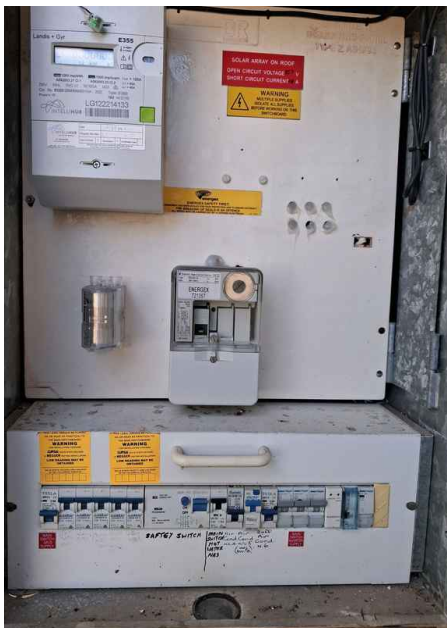
#### Electrical : Safety Switch Observed

A safety switch (residual-current device) was observed; however, **it was not tested** for function, safety, or compliance. Testing of RCDs is **outside the scope** of this inspection in accordance with AS 4349.1 Cl. 2.3.

It is strongly recommended that the **entire electrical system**, including the RCD, be inspected and tested by a **licensed electrician** prior to use.

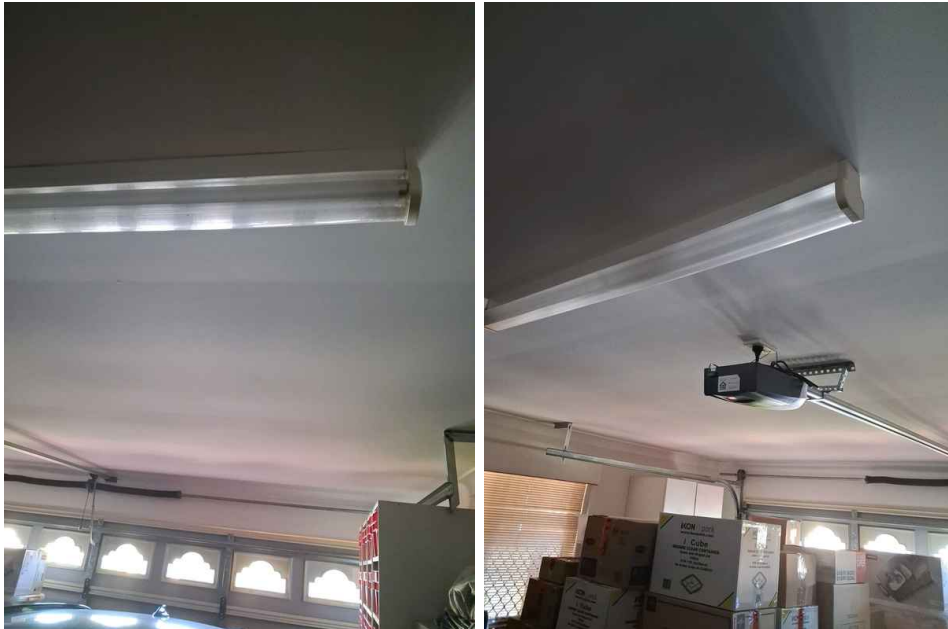
Undulations were noted to the ceiling lining. Common in a house of this age. Consult a qualified plasterer for further assessment and repairs as required.

Note: This can be an indicator of failure of fasteners and/or moisture damage.

Contact a qualified drywall contractor.

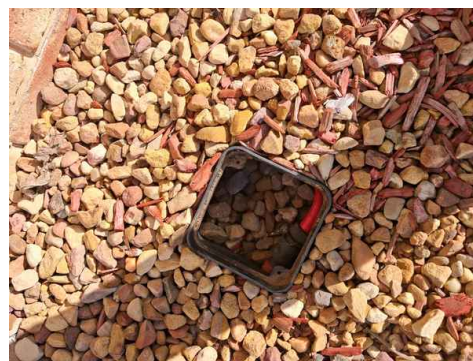
**RETICULATION SYSTEM**

A reticulation system may be present as there are pipes present (with inspection points) located in the path around the perimeter of the house. Termite reticulation systems installed during or after construction to assist in the protection of the structure against subterranean termite attack. We strongly recommend any prospective purchaser attempt to verify these findings and ask the seller for full details of this system. It is important to verify the extent of this system as some reticulation systems cover only part of the property.

Contact a qualified professional.
