## BUILDING & PEST INSPECTION REPORT

25 Keith St  
Kuraby, QLD 4112

03/09/2026

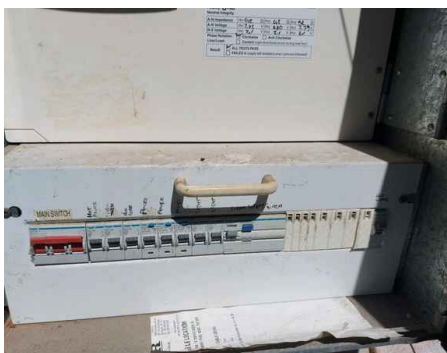
A safety switch (residual-current device) was observed; however, **it was not tested** for function, safety, or compliance. Testing of RCDs is **outside the scope** of this inspection in accordance with AS 4349.1 Cl. 2.3. It is strongly recommended that the **entire electrical system**, including the RCD, be inspected and tested by a **licensed electrician** prior to use.

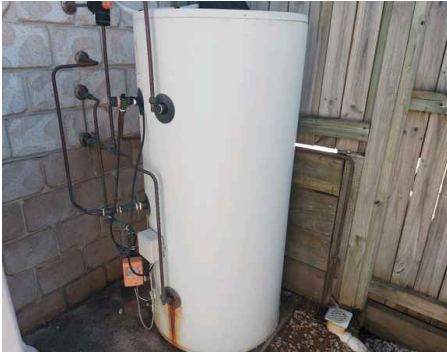
Electric Water Heater (Tank)

No determination has been made regarding its compliance, suitability, capacity, functionality, or remaining service life. Assessment of such systems is outside the scope of this inspection (AS 4349.1 Cl. 2.3).

For confirmation of condition and performance, further evaluation is recommended by a licensed plumber prior to purchase or use.

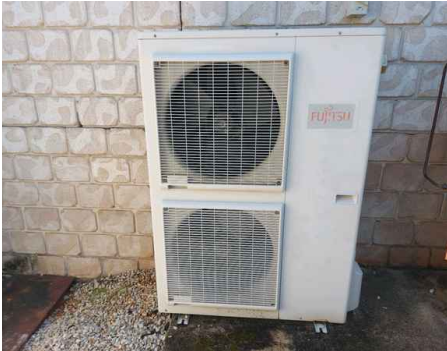
Air-conditioning systems were observed but not tested for operation, performance, or compliance. Evaluation of these systems is outside the scope of this inspection. We recommend assessment by a licensed air-conditioning specialist to determine their condition, functionality, and any maintenance or repair needs.

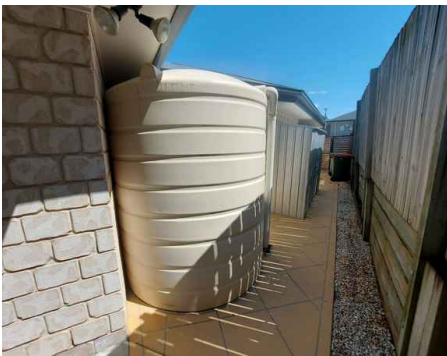
The inspection of water tanks is excluded from the scope of this report. It is recommended that a licensed plumber inspect the tanks to confirm correct installation, condition, and compliance with all relevant regulations and standards.

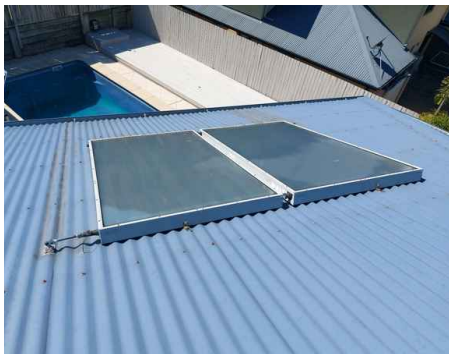
Solar panels or other fixtures obstructed some areas of the roof surfaces from being inspected.

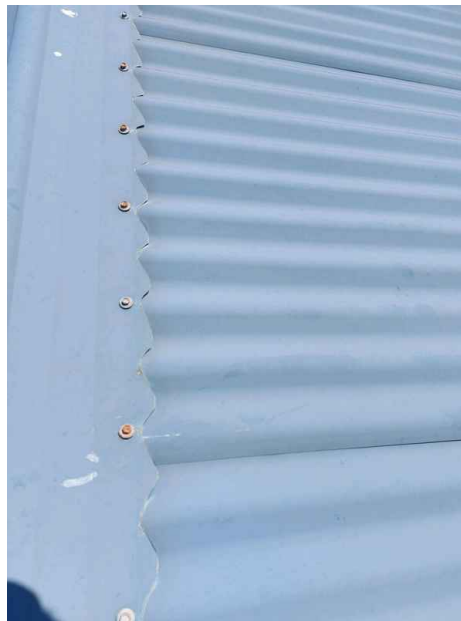
Where observable, the Inspector observed no major deficiencies at the time of the inspection.

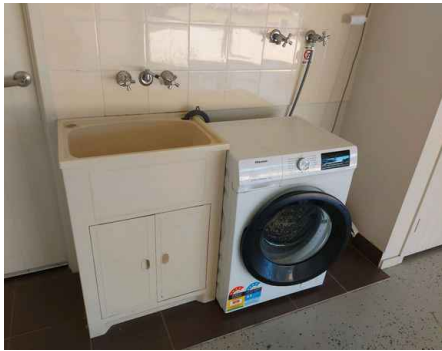
The Inspector observed no major deficiencies at the time of the inspection.

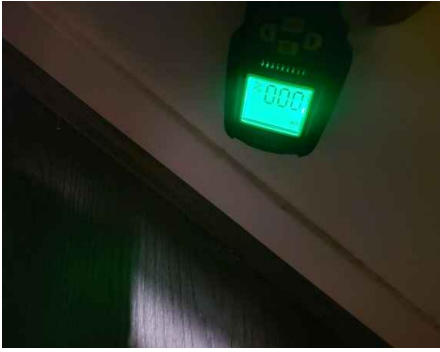
No high moisture levels were detected at the time of the inspection.
