# **PRE SALE PROPERTY INSPECTION**

1 Pomeroy Close, Underwood

# Visual Pre Purchase Building & Timber Pest Inspection Report

To comply with Australian Standard AS4349.1-2007 and AS4349.3-2010

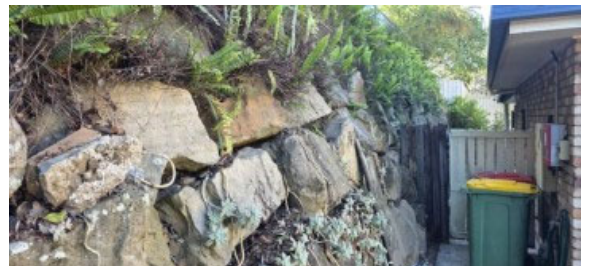
The masonry retaining walls appear in fair condition.

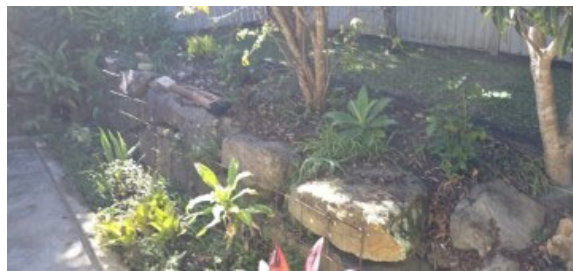
The retaining wall appears to be under designed. Recommend that you seek advice from Structural or Geotechnical Engineer.

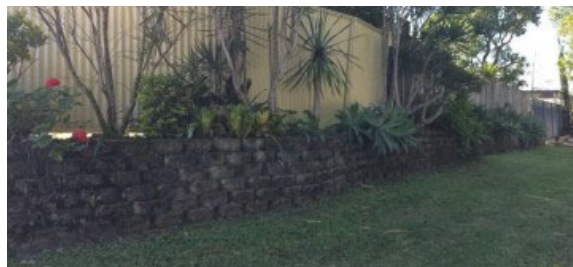
The retaining wall appears to be under designed. Recommend that you seek advice from Structural or Geotechnical Engineer.

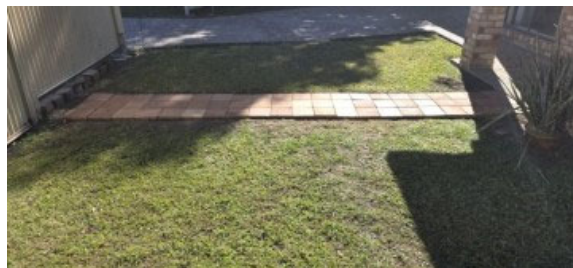
The paved paths/paved areas have subsided in areas and will require repair and or relaying.

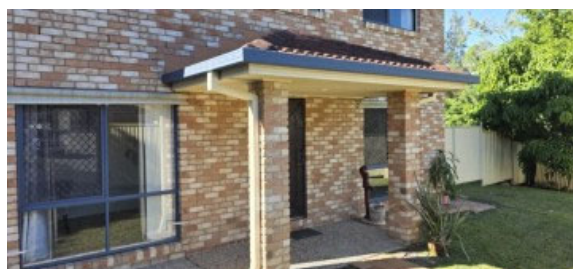
**FRONT ENTRY****Position/Location:**

The general condition of this structure is fair.

Trim timbers are loose and rectification is required  
Ceiling/soffit lining requires repair and or maintenance.

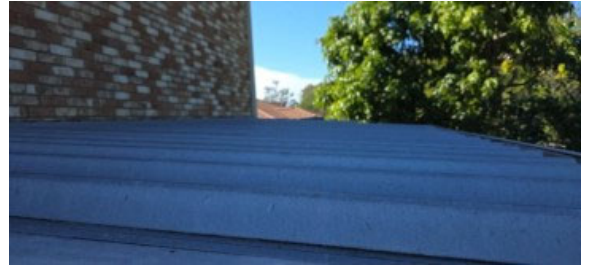
The overall condition of the roof coverings is fair.

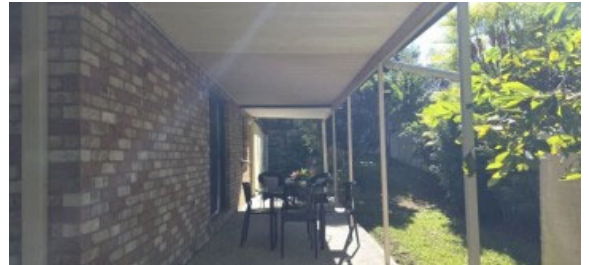
**PERGOLA****Position/Location:**

The general condition of this structure is fair.

Roof area should be cleaned to remove, lichen and or moss buildup. Some repair & maintenance of the roofing material may be required following clean. A roofing expert should further evaluate the roof area.

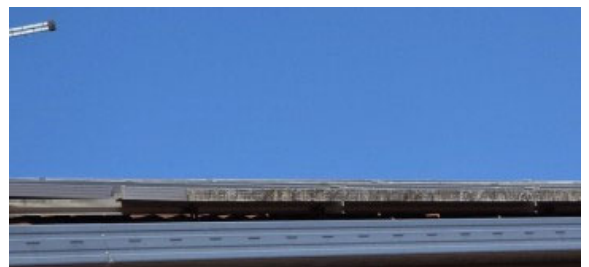
The overall condition of the roof coverings could not be determined due to limited access.

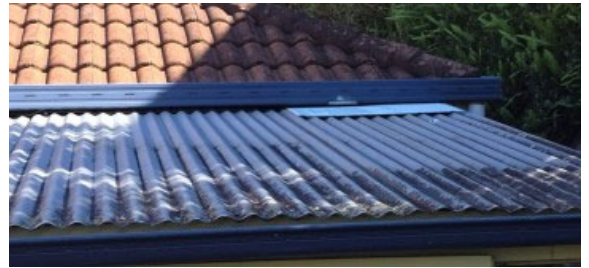
Roof area should be cleaned to remove, lichen and or moss buildup.

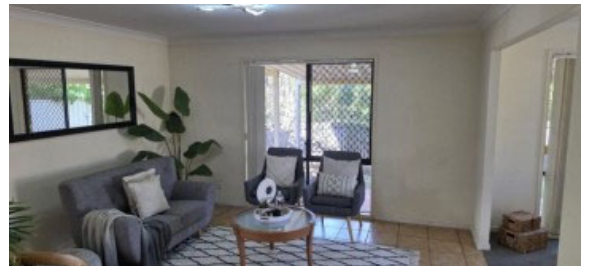
**REAR LOUNGE ROOM:****Room Location:**

Minor maintenance and or repairs are required prior to next repainting.

Settlement cracks are evident to wall areas. Maintenance and repairs are required prior to next repainting.

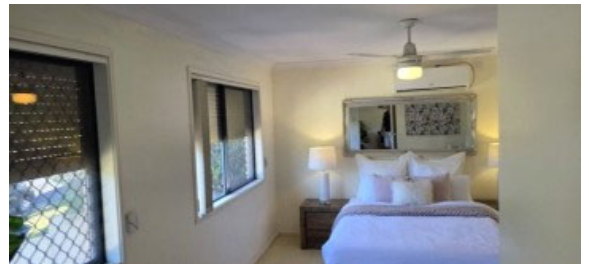
**BEDROOMS****BEDROOM ONE:****Room Location:**

Minor maintenance and or repairs are required prior to next repainting.

Squeaking or loose flooring was noted. Consider securing these areas to prevent movement.

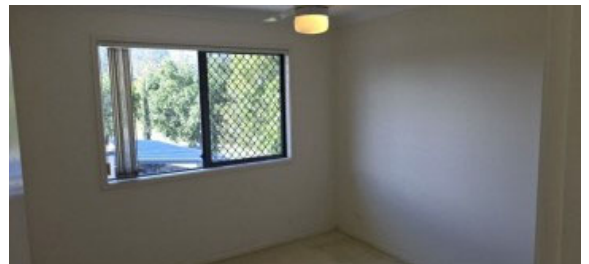
**BEDROOM TWO:****Room Location:**

Minor maintenance and or repairs are required prior to next repainting.

The door binds and adjustments are required to ensure correct operation.

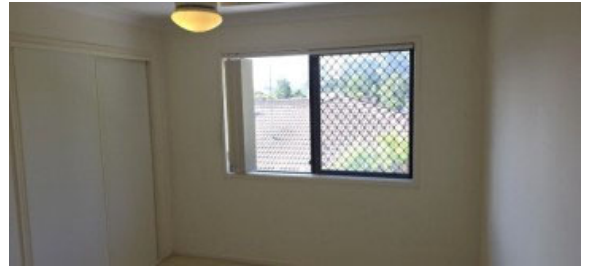
**BEDROOM THREE:****Room Location:**

Minor maintenance and or repairs are required prior to next repainting. Squeaking or loose flooring was noted. Consider securing these areas to prevent movement.

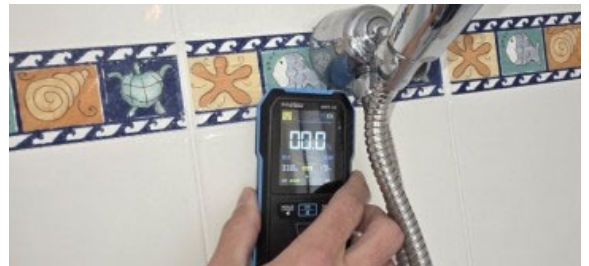
The shower recess was tested and there was no visible water penetration to surrounding areas. IMPORTANT NOTE: This test may not reveal water leaks until the shower is put into constant use and surrounding areas monitored over a period of time. Recommend all aging, worn and or missing tap hardware be professionally serviced and or upgraded.

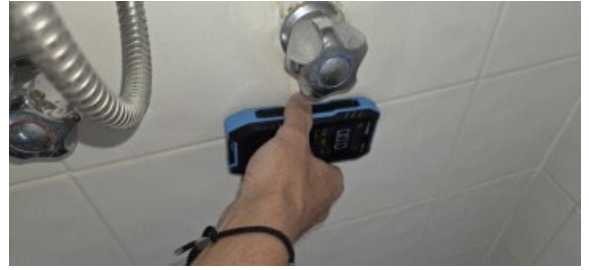
Junction of wall finish and shower base should be resealed appropriately to prevent water entry to wall cavity.

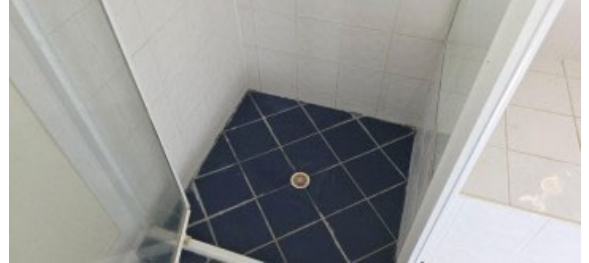
Junction of shower screen and shower base should be resealed appropriately to prevent water entry to wall cavity.

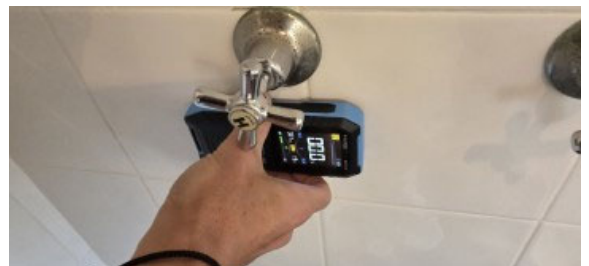
The shower recess was tested and there was no visible water penetration to surrounding areas. IMPORTANT NOTE: This test may not reveal water leaks until the shower is put into constant use and surrounding areas monitored over a period of time.

Recommend all aging, worn and or missing tap hardware be professionally serviced and or upgraded.

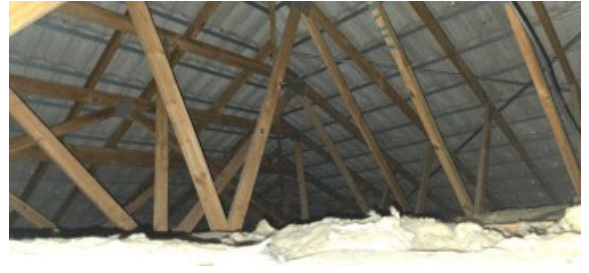
The truss roof system is adequate for the roof covering.

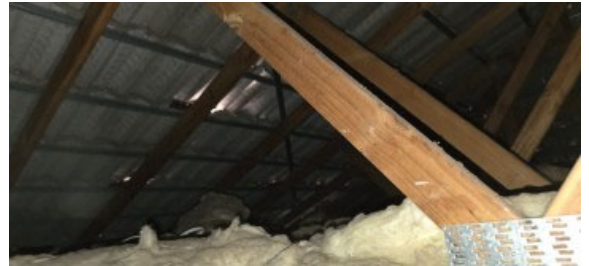
The truss roof system is adequate for the roof covering.

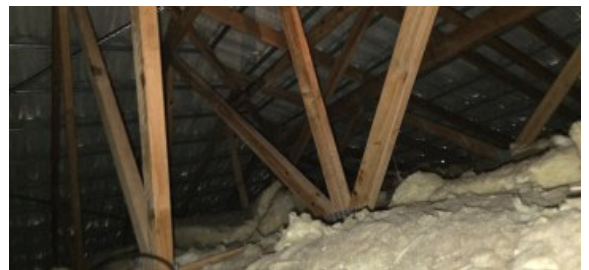
The truss roof system is adequate for the roof covering.

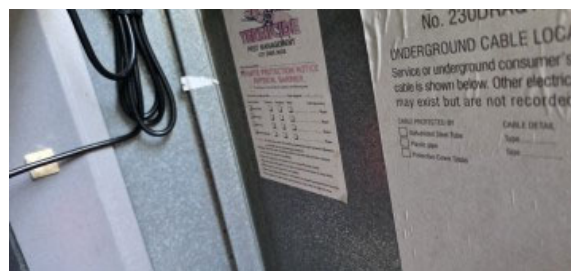
Yes - We found evidence that a termite treatment may have been carried out to this property. Where any evidence of a termite treatment or termite management system was noted, we recommend any prospective purchaser research the documentation available in relation to this property and seek further information from the vendor in relation to any previous termite attack. The following evidence was found during our inspection;
